Navajo Abandoned Uranium Mine Site Screen Report

Section 18 SEQ AUM Site

Navajo AUM Eastern Region

May 2009

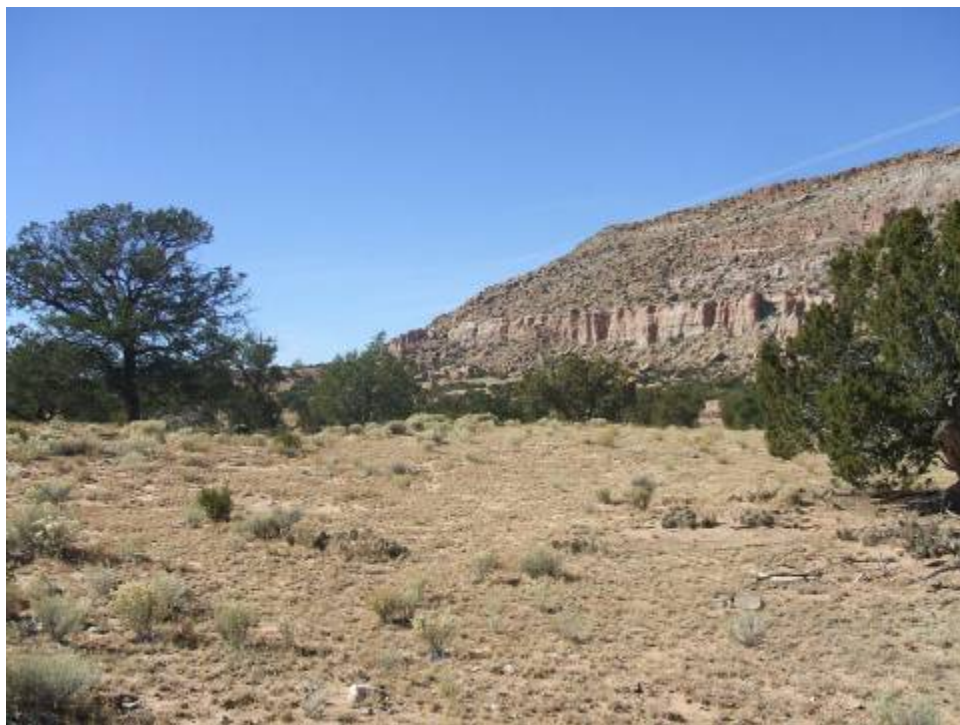
Photo 1. Section 18 SEQ mine site, towards the southwest

Reclamation status of the mine site is currently unknown. No waste pile, pits, adits or other mine features were observed during the site visit.

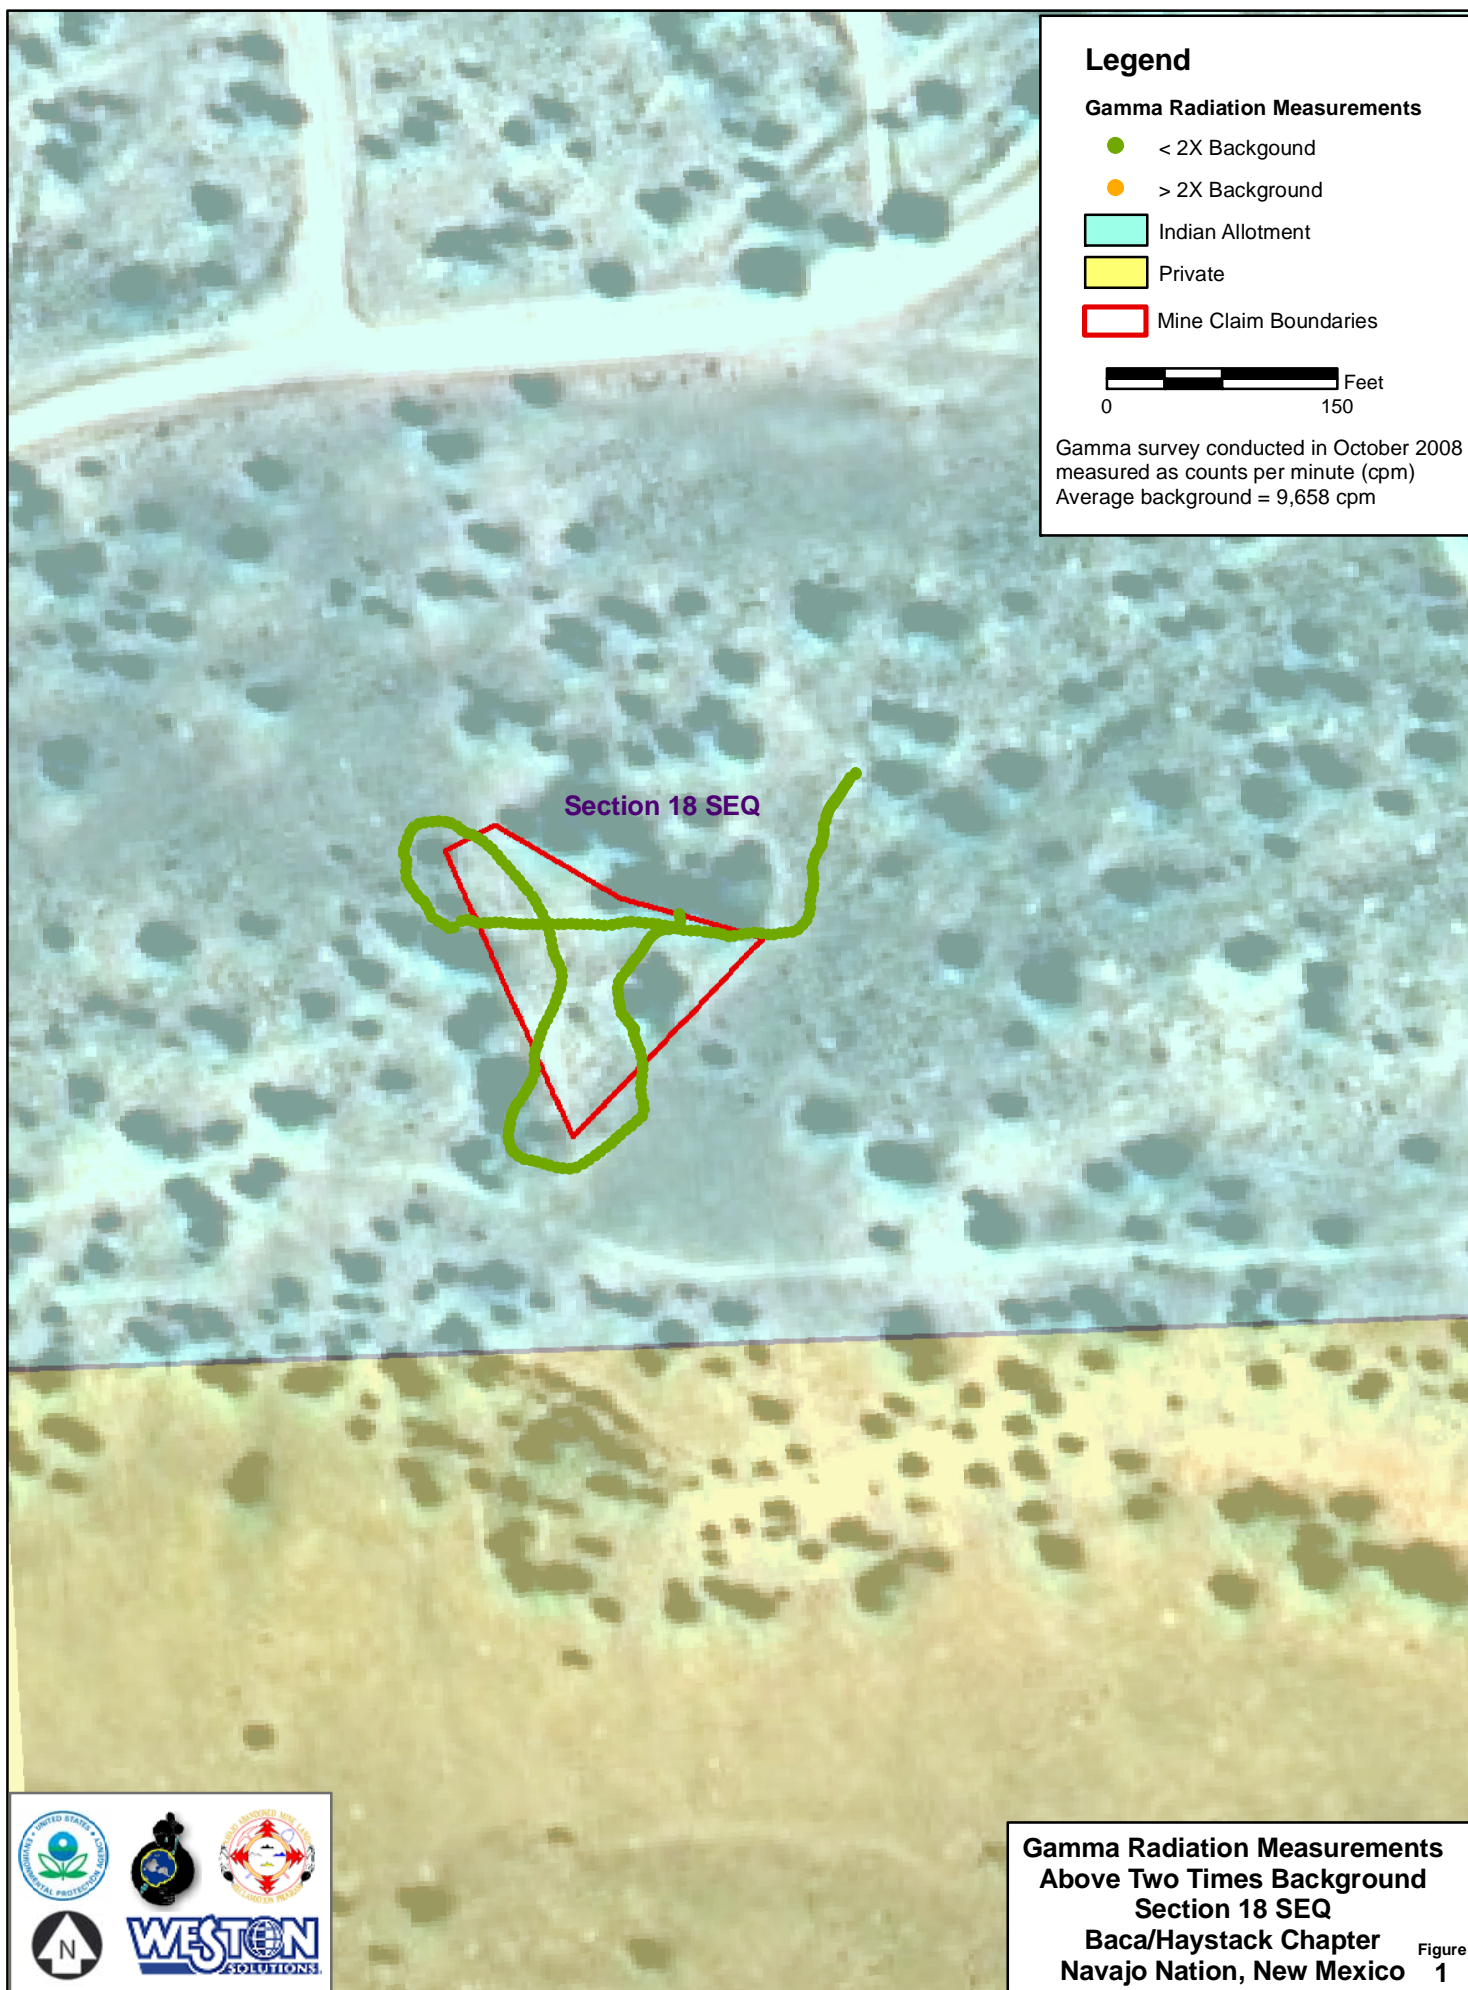
**Gamma Radiation Measurements
Above Two Times Background
Section 18 SEQ
Baca/Haystack Chapter
Navajo Nation, New Mexico**

A total of 253 gamma radiation measurements were collected from mine sites, ranging from 6,469 cpm to 8,775 cpm. The measurements are represented in Figures 1 and 2.
